## Telephone Box at Robertsbridge Station

October 2024

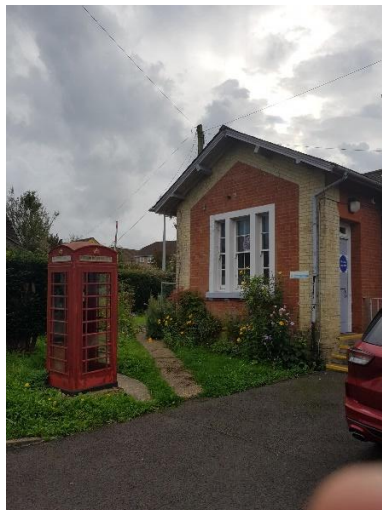
Phone box position at entrance to Station facility

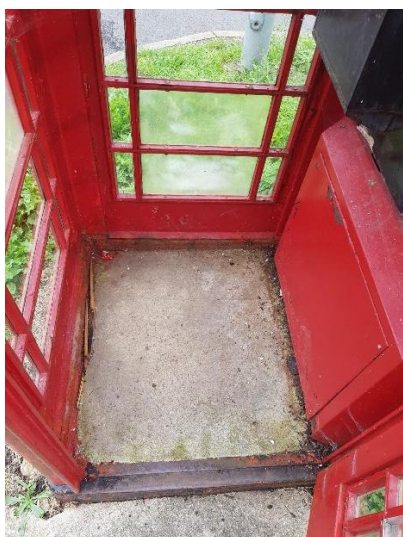
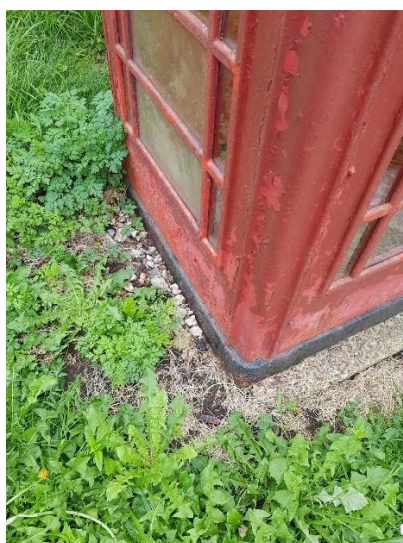
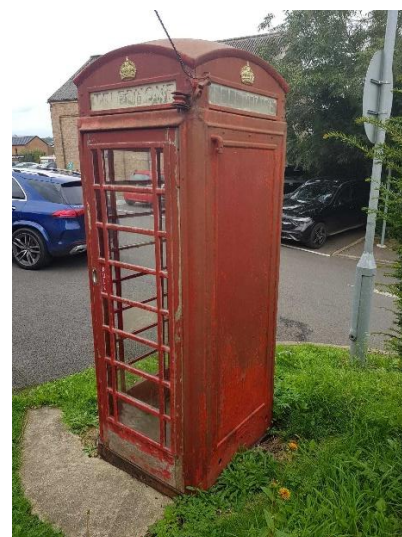
Internal base is sound but does have a slope to the inside far wall. No sign of separation between the concrete base and metal base frame. Internal finish shows signs of age and would need sanding back and re-painting. Threshold is sound although shows signs of use.

External base shows signs of crumbling to far wall which could be repaired with a waterproof cement mix. The crumbling does not extend under the metal base.

Entrance path is sound and slopes away from box, needs cleaning and weed clearance to define edges.

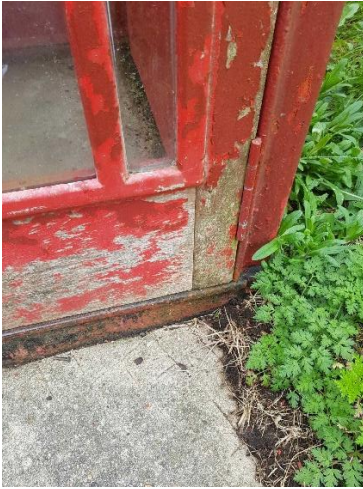
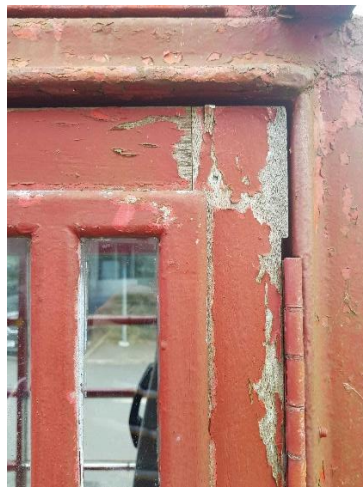
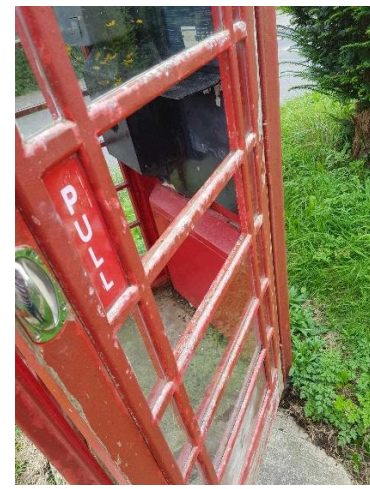
Door is sound and hinges are intact and operational. Wood is sound but needs sanding back and priming and painting. Two panes of glass are missing and need replacing with glass rather than plastic, to match existing. Needs new retention frames to hold new glass in place. Water that puddles inside comes in through these apertures.

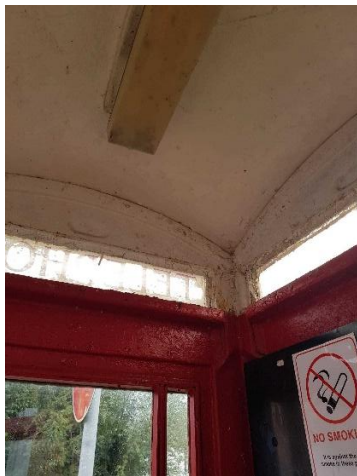
Roof is sound although needs re-decorating. The labelled glass between the roof and walls has faded writing which needs replacing with new or new signage painted to show what the phone box is now used for or with heritage words or descriptions.

Internal light to be replaced with equivalent LED with PIR control for darkness and timing of illumination. Power supply already installed but may need upgrading to current specification.

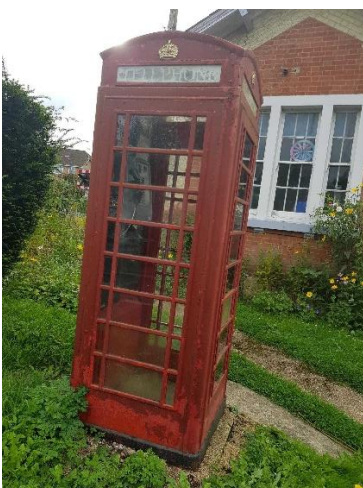
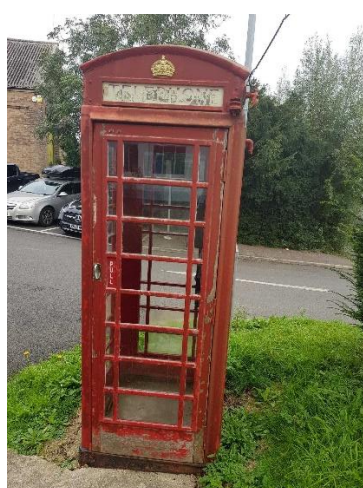
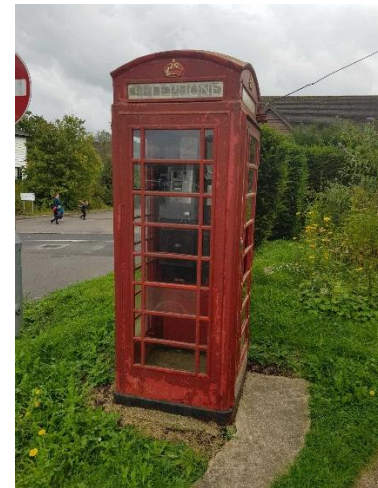
General external finish is sound but does need re-decoration. Signage needs re-defining, including the gold crown motif. Possible additional plaque outside giving the heritage and history and involvement of partners that bought and refurbished this icon.
